MPIC PROPERTY POINTERS

SEPTEMBER 2022

NAIL POPS AND ASPHALT ROOFS

By Richard T. Abbott, PE, SE, Abbott Consulting Forensics and Design

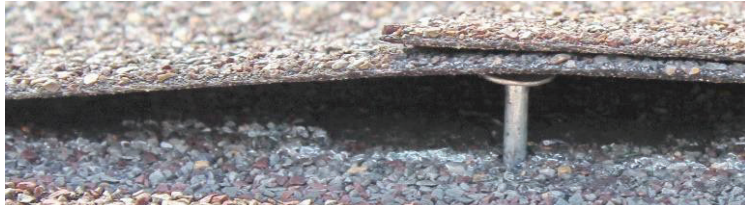
A protruding nail is a common problem found on asphalt shingle roofs. The roofing industry refers to these as nail pops. The image below shows a typical nail pop. The nail actually pops up and out of the wood deck causing the shingle to be lifted. The nail backs out of the wood deck where it once had been adequately inserted to the correct depth.

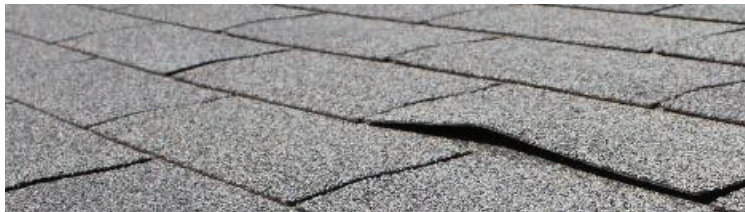
It is common for people to view their roof from the ground and incorrectly come to a false conclusion of wind damage. When viewing the distortion from the roof, a shingle may be found to be in an upward position due to a nail head. The image below shows a shingle tab being pushed upward by a nail. It cannot lay flat.

When the nail head protrudes upward the nail head pushes on the underside of the shingle. As the shingles cycle through extreme heat, the nail head cuts into the asphalt shingle. Eventually, the nail head pops out of the outer surface of the shingle and a hole is created where water can enter the roof. As water continues to enter the roof, the wood deck warps and rots with time. The problem will worsen over time.
